**MONUMENT RECORD**  
 CORNER ID:  
**CICr\_L22**

**N-E 1/16 Corner**  
 Section 33- T07N-R01W  
 Clear Creek Township  
 Monroe County, Indiana

**OFFICE OF THE MONROE COUNTY SURVEYOR**  
 Trohn Enright-Randolph Monroe County Surveyor  
 Rachel Savich Oser Professional Surveyor  
 119 West 7th Street, Bloomington, IN 47404 (812) 349-2570

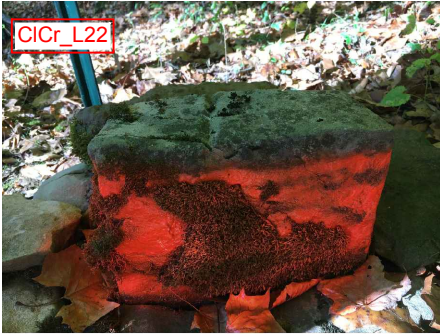
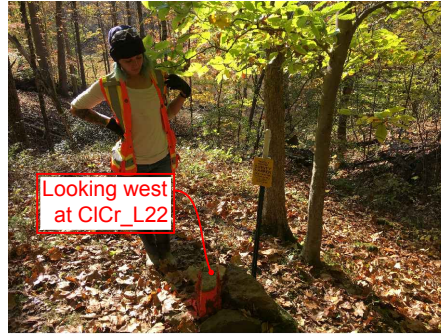
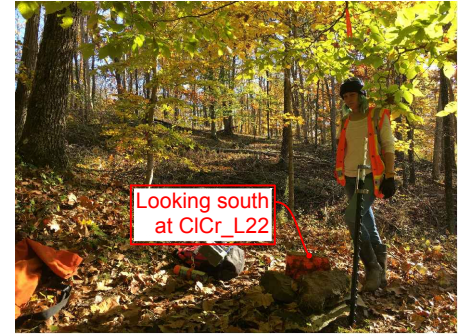
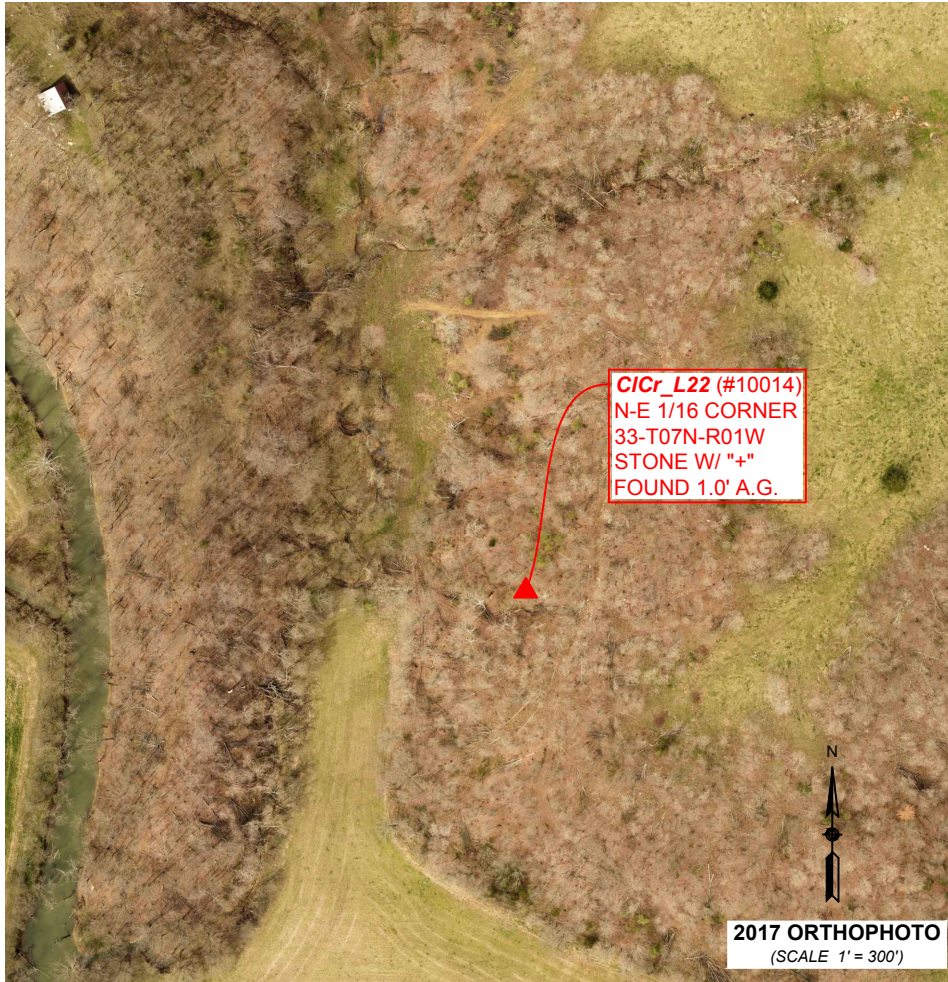
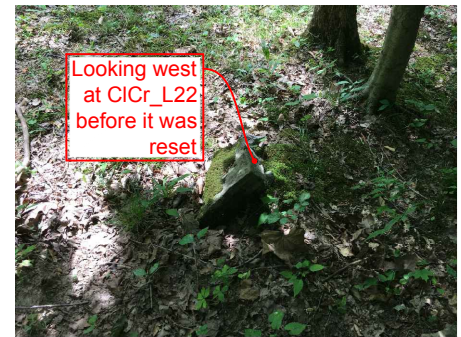
The stone was found leaning. I dug it up and then reset it in the same hole after checking the sides for additional markings. The stone was replanted with 1.0' above grade, spray painted orange, and protected with a rock cairn.

- ▲ **Monument Description:** A 0.8' x 0.3' limestone with a 0.25' x 0.3' cut "+" 1.0' above grade on the east side of a north/south ravine, spray painted orange, and protected with a rock cairn.  
**State Plane Grid Coordinates:** Point No.: 10014 Northing: 1367884.4', Easting: 3112348.1'

Photos were taken on 08/16/2017 and 11/03/2017 with an iPhone 6s
